west virginia department of environmental protection

**CONSENT ORDER  
ISSUED UNDER THE  
WATER POLLUTION CONTROL ACT  
WEST VIRGINIA CODE, CHAPTER 22, ARTICLE 11**

TO: MarkWest Liberty Midstream & Resources, L.L.C.      DATE: March 28, 2019  
Gregory Bezdek, SVP, NE Region  
4600 J Barry Ct. Ste 500  
Canonsburg, PA 15317      ORDER NO.: 8945

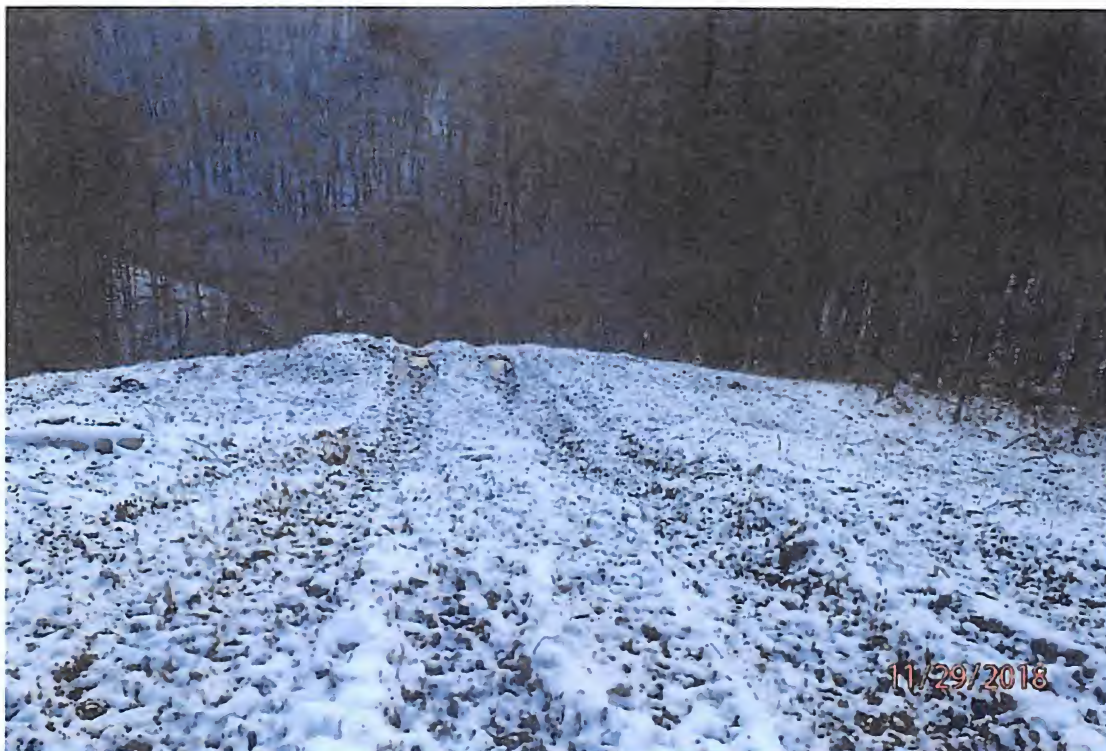
Inspected area from 675+00 to 682+00 showing the lack of water bars as indicated in the approved SWPPP.

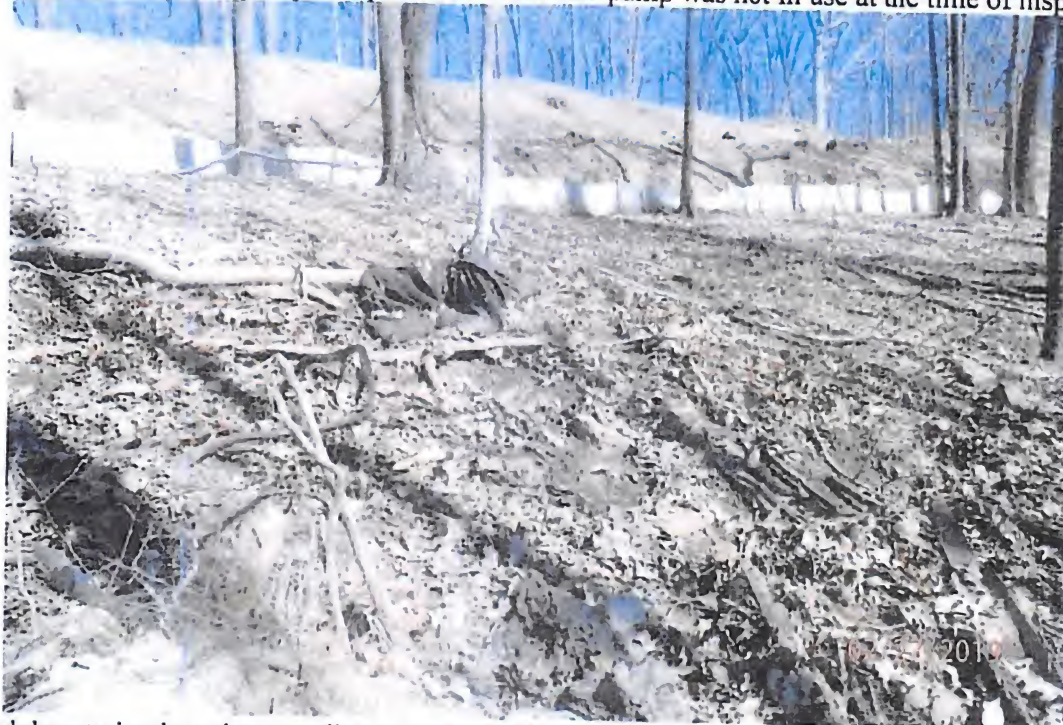
Installed dewatering bag that contributed to the visible plume in UNT Boggs Run showing the lack of an installed geotextile lined flow path and the associated erosion downslope of the device.

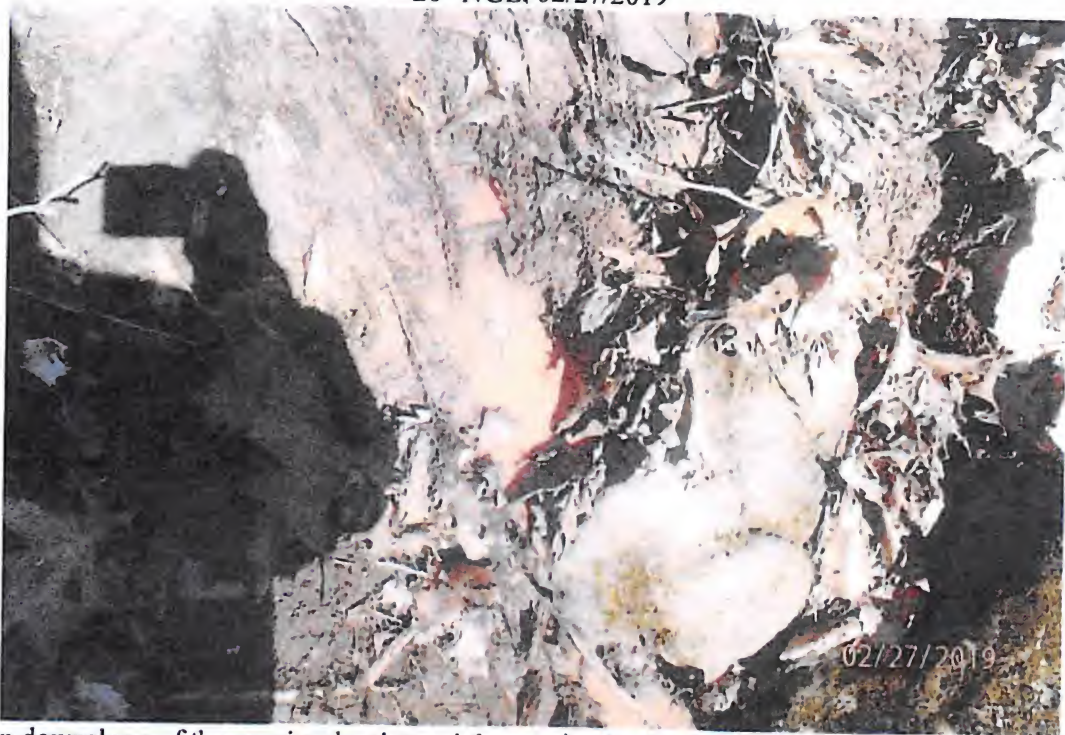
Erosion downslope of the previously pictured dewatering bag in the Boggs Run watershed showing the lack of an installed geotextile lined flow path and the associated erosion downslope of the device.

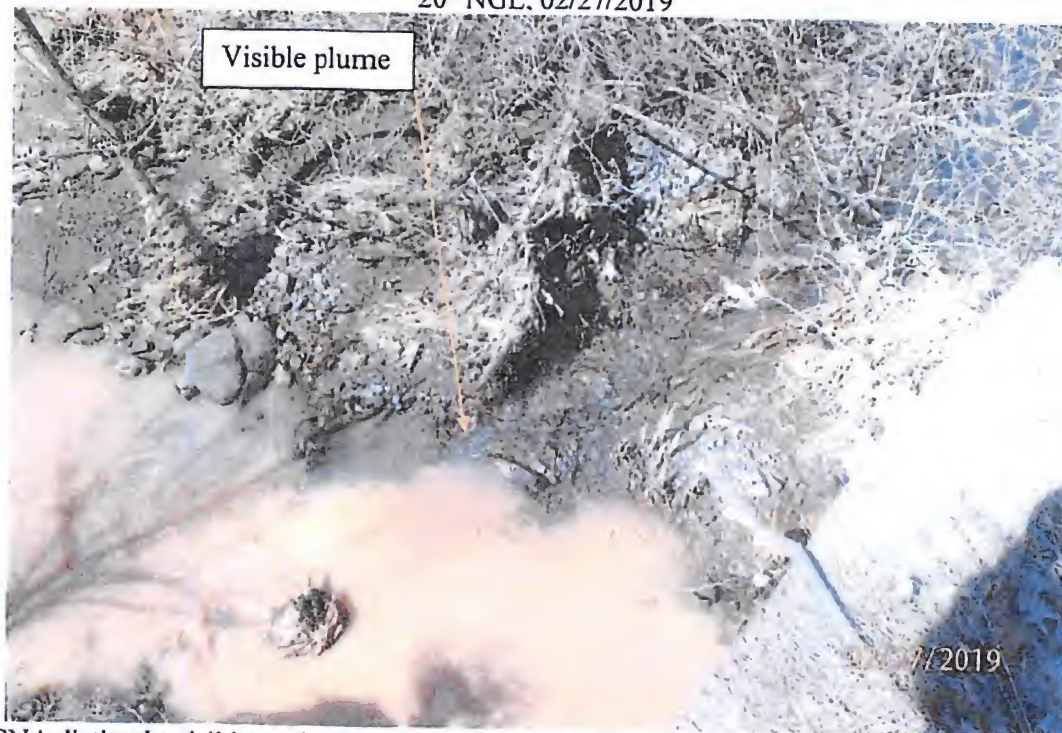
CNA distinctly visible settleable solids in Boggs Run as a result of the dewatering operation.

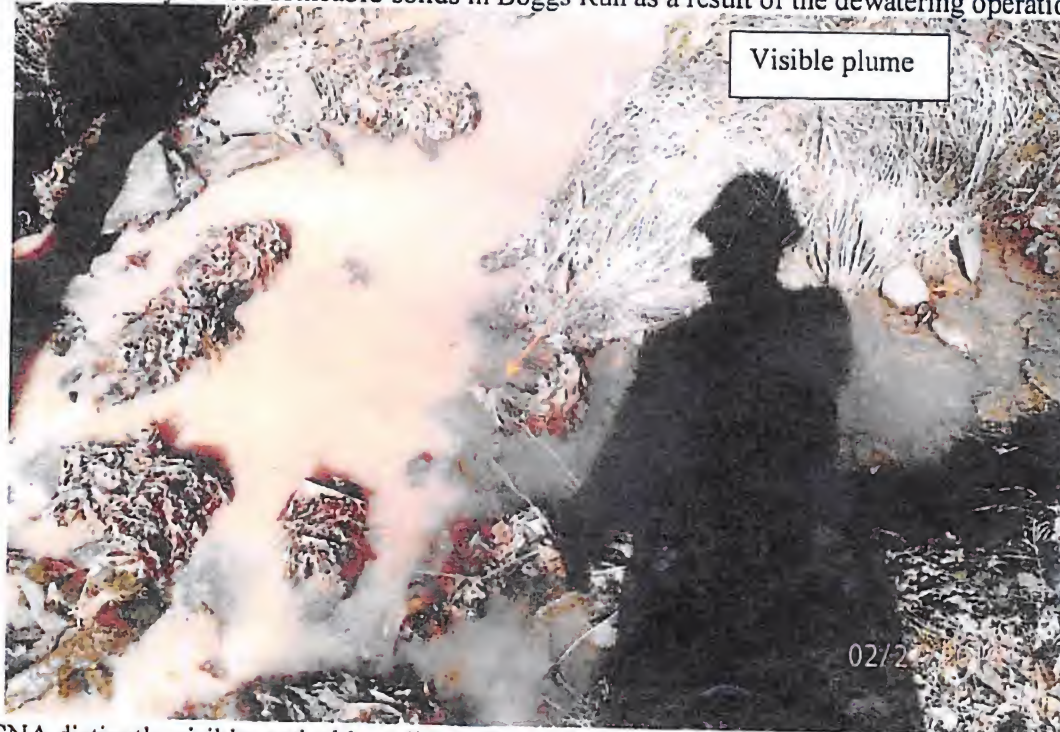
CNA distinctly visible settleable solids in Boggs Run as a result of the dewatering operation.
